Multidisciplinary treatment approach to a complicated crown fracture: A case report

This case report presents multidisciplinary treatment approach in a 12-year-old male patient who suffered from a complicated crown fracture of the maxillary right central incisor that occurred due to a fall. The patient was evaluated from a multidisciplinary vantage point to provide function and esthetics. First, the fractured segment was removed from the tooth and gingivoplasty was performed. Fiber post was applied following root canal treatment and temporary restoration was performed. The axes of the teeth were corrected with short-term (4 months) fixed orthodontic treatment, and esthetic and appropriate tooth position was achieved on the zirconia-reinforced ceramic crown. A zirconia-reinforced ceramic crown was made using computer-aided design and manufacturing. A satisfactory esthetic appearance and function were achieved following the treatment. No problems were encountered in the tooth and periodontal area during the follow-up appointments. This case shows the significance of a multidisciplinary treatment approach in traumatized teeth.

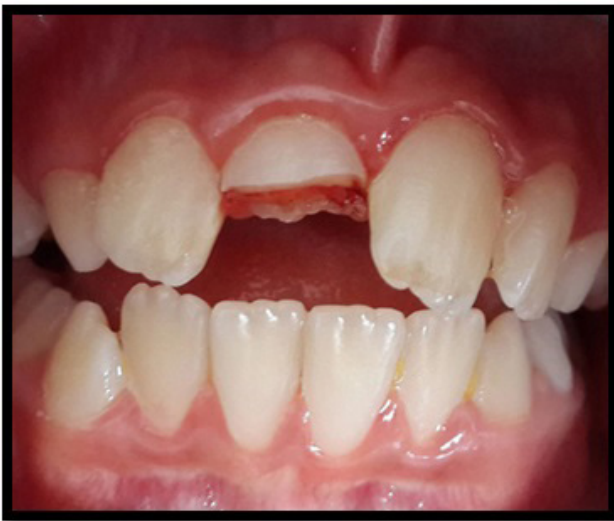
Figure 1: Intraoral buccal and occlusal view of the traumatized maxillary right central incisor with complicated crown fracture

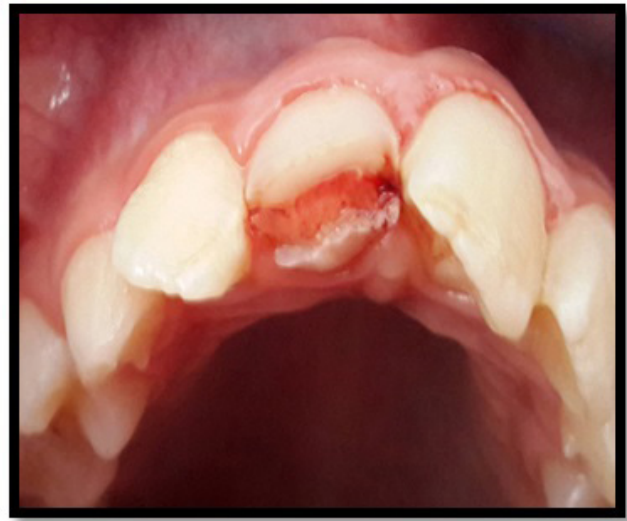
Figure 2: Intraoral buccal and occlusal view of the traumatized maxillary right central incisor with complicated crown fracture

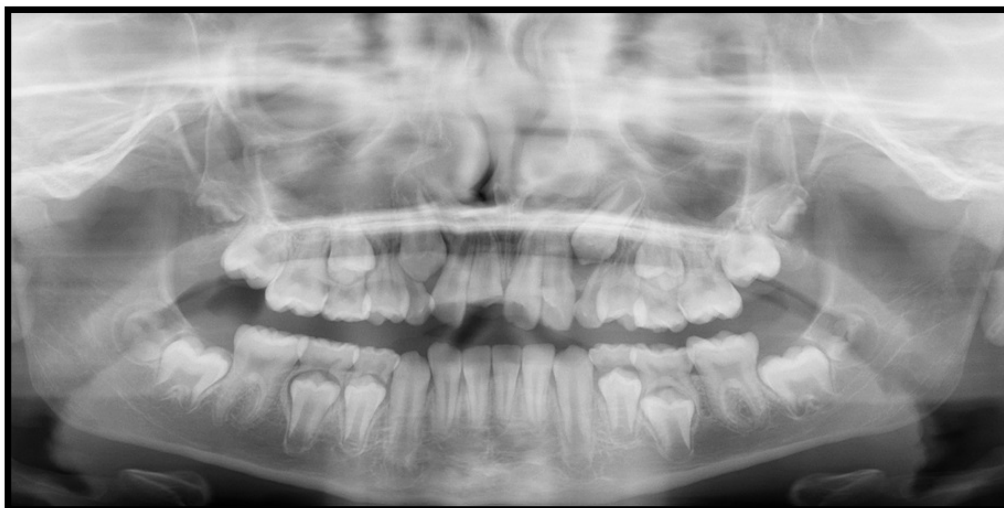
Dentistry, Faculty of Dentistry, Cumhuriyet University, Sivas, Turkey because of a CCF in the maxillary right central incisor. Dental trauma has occurred 2 h prior as a result of a fall in school, and the fractured part was lost. The clinical examination did not reveal any abnormal notable evidence outside the mouth. The intraoral examination revealed a CCF of the maxillary right central incisor [Figures 1 and 2]. The radiologic examination, conducted with panoramic and periapical radiographies, revealed a horizontal fracture line in the maxillary right central incisor, while there was not any fracture or abnormal image of the chin, face, or alveolar bones [Figures 3 and 4].

Figure 3: Preoperative panoramic view of the patient after dental trauma

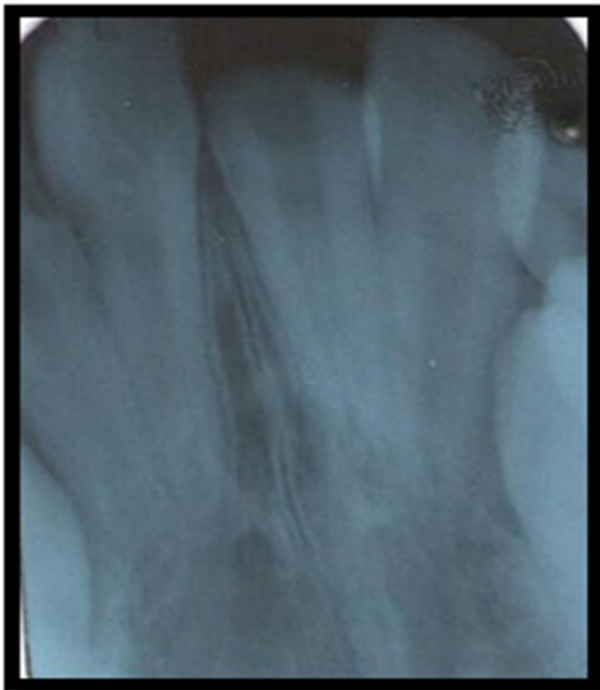
Figure 4: Preoperative intraoral periapical radiograph of the patient after dental trauma

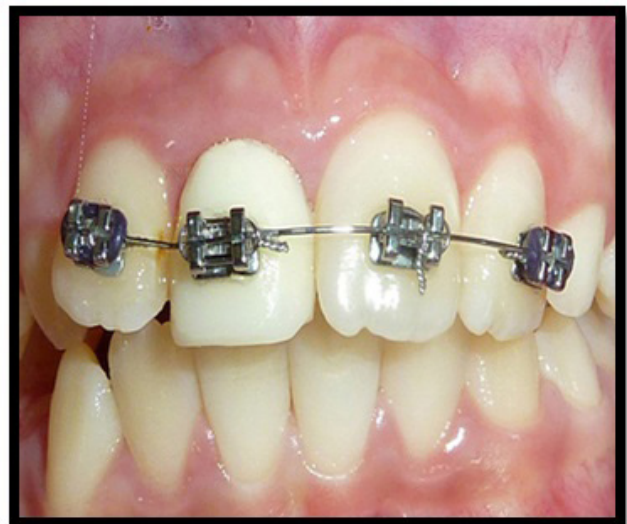
Figure 5: Leveling and sequencing maxillary incisors of the patient with a short-term (4 months) fixed orthodontic treatment

Because of impairment in axes of the adjacent teeth, there was not sufficient space for zirconium supported ceramic restoration, and therefore, fixed orthodontic treatment was indicated in the maxillary incisors. During the fixed orthodontic treatment that lasted 4 months, leveling and sequencing procedures were performed in maxillary incisors [Figure 5]. Following active orthodontic treatment, brackets were removed, and reinforcement treatment with

retainer was applied on the adjacent maxillary incisors to prevent relapse of previous positions.

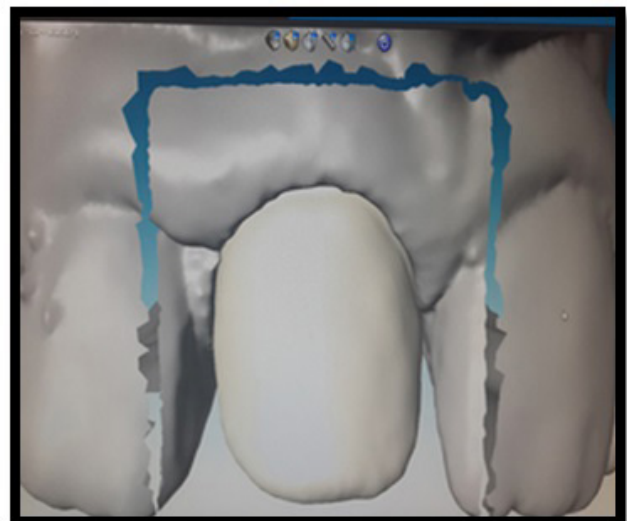
Figure 6: Preprosthetic planning of the zirconia-reinforced ceramic crown using computer-aided design and manufacturing

The model obtained following the permanent mold taken with silicon from the patient was screened by the Dentalwings program (Yenadent D-Series, Katana™, Noritake) and transferred to a computer [Figure 6]. The restoration, which was designed on a computer, was then shaped in the router unit and treated with a sintering process for 10 h in a sinter oven. Following cementation, an appropriate esthetic appearance was achieved [Figure 7]. The patient was called for routine follow-up appointments on 1st, 3rd, 6th, and 12th months, and the radiologic follow-up was conducted [Figures 8 and 9]. In addition, orthodontic follow-up was planned for every 6 months.

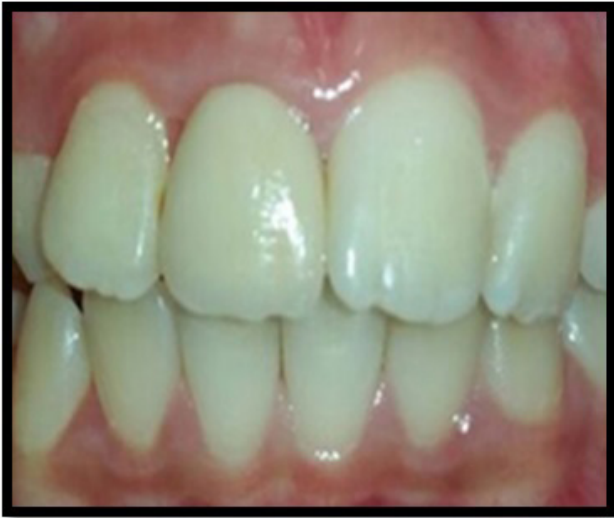
Figure 7: Intraoral view of the 1-week follow-up exam after prosthetic rehabilitation

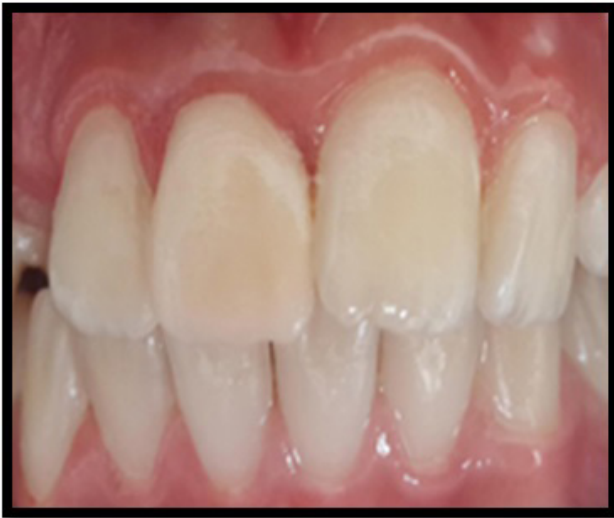
Figure 8: Intraoral view of the 12-month follow-up exam

In this clinical case report, which shows the importance of a multidisciplinary approach to meet the esthetic and functional needs, the traumatized maxillary right central incisor was in a satisfactory condition to meet the desired esthetic and functional need after the treatment. The clinical and radiological evaluation of the patient after 12 months revealed that the tooth and periodontal tissues were healthy.

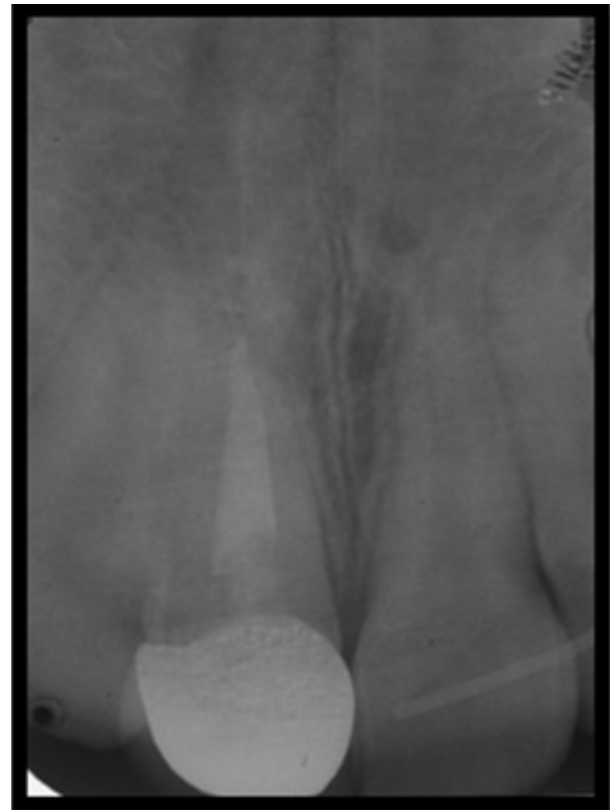
Figure 9: Intraoral periapical radiograph of the 12-month follow-up exam
